Water Compliance Inspection Report

**NPDES
Inspection Report**

**Dan Noteboom Dairy
Lynden, Washington**

March 29, 2010

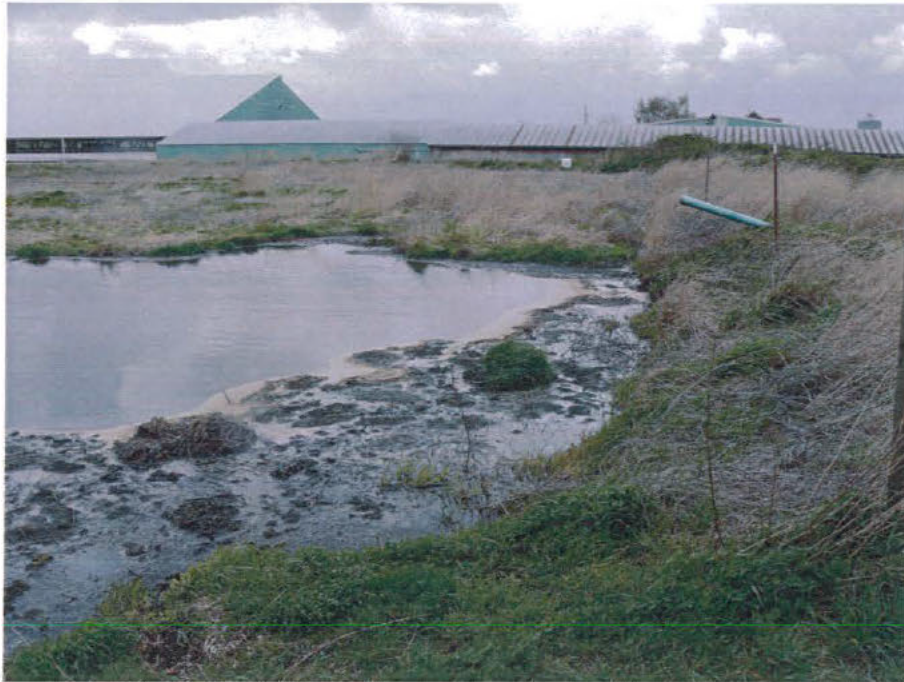
- A. Solids Accumulation in the Waste Storage Lagoons At the time of the inspection, I saw solids floating on the surface of the waste storage lagoon at the main facility. In addition to the solids, I saw vegetation growing on the surface of these floating solids. See photograph #s 1 to 4 of attachment C for details of these accumulated solids in the main facility lagoon.

The accumulated solids and vegetation on the main facility lagoon were thick enough such that it could support the weight of a large dog. At the time of the inspection, the dog owned by Mr. Noteboom walked onto the surface of the lagoon at the main facility.

The nutrient management plan suggests that this facility is designed to be operated with a certain amount of waste storage capacity in the waste containment system. The concern, however, is that by not cleaning out the solids from the lagoons on a regular basis the available storage capacity in these lagoons has decreased and will continue to decrease. In subsequent years, this can result in land application to nearby fields during times that are less desirable for land application.

Photo #1: Westerly view showing the northeast corner of the (main facility) waste storage lagoon in the foreground. Note the vegetation on the lagoon surface. The only area within the lagoon without solids on the surface is the northeast corner which is where waste is pumped from the lagoon.

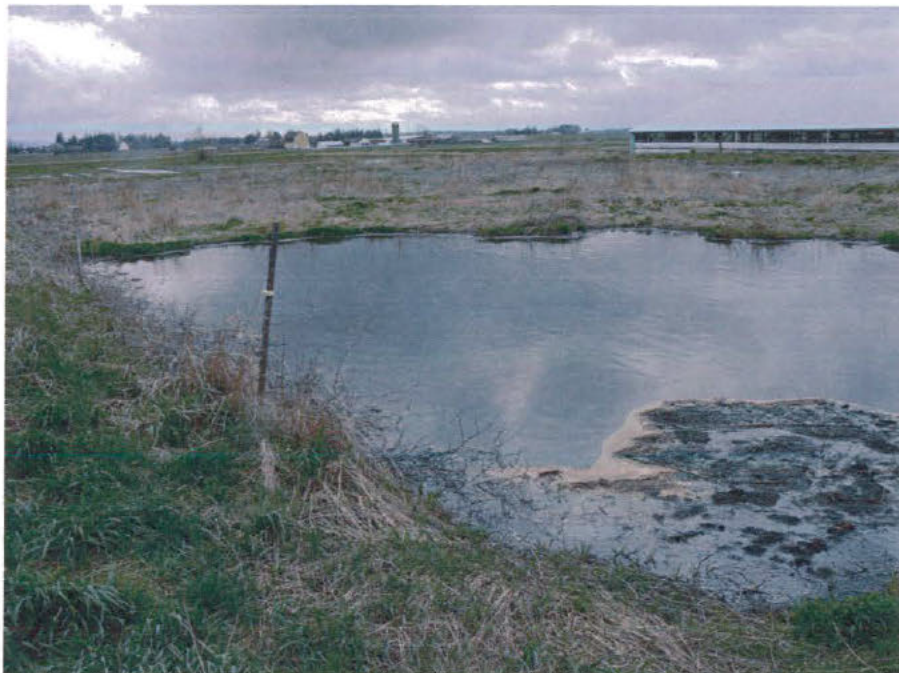
Photo #2: Southwesterly view showing the northeast corner of the (main facility) waste storage lagoon in the foreground. Note the vegetation on the lagoon surface. The only area within the lagoon without solids on the surface is the northeast corner which is where waste is pumped from the lagoon.

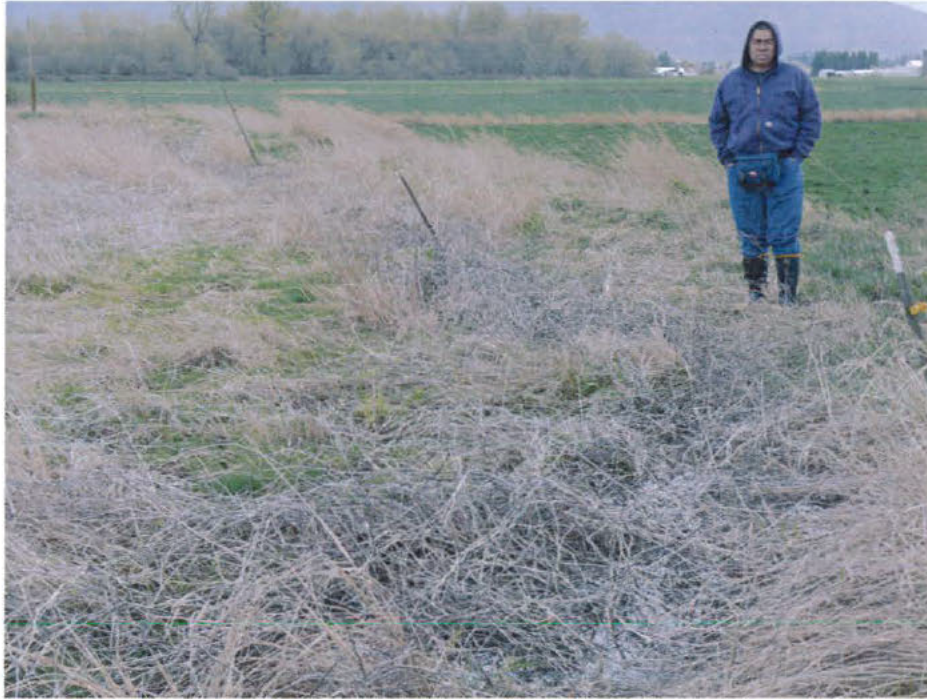
- B. Freeboard in the Lagoon at the Main Facility The nutrient management plan for this facility specifies at least one foot of freeboard in the lagoons.

At the time of the inspection of the lagoon at the main facility I saw that the level in the lagoon was approximately six inches or less from the top of the lagoon wall along portions of the lagoon. See photograph #s 3 and 4 of attachment C for details.

Photo #3: Easterly view showing the southwest corner of the (main facility) waste storage lagoon. Note that I am standing on the lagoon wall. Note the amount of vegetation floating on the lagoon surface. Also note that there is less than six inches of freeboard in this portion of the lagoon.

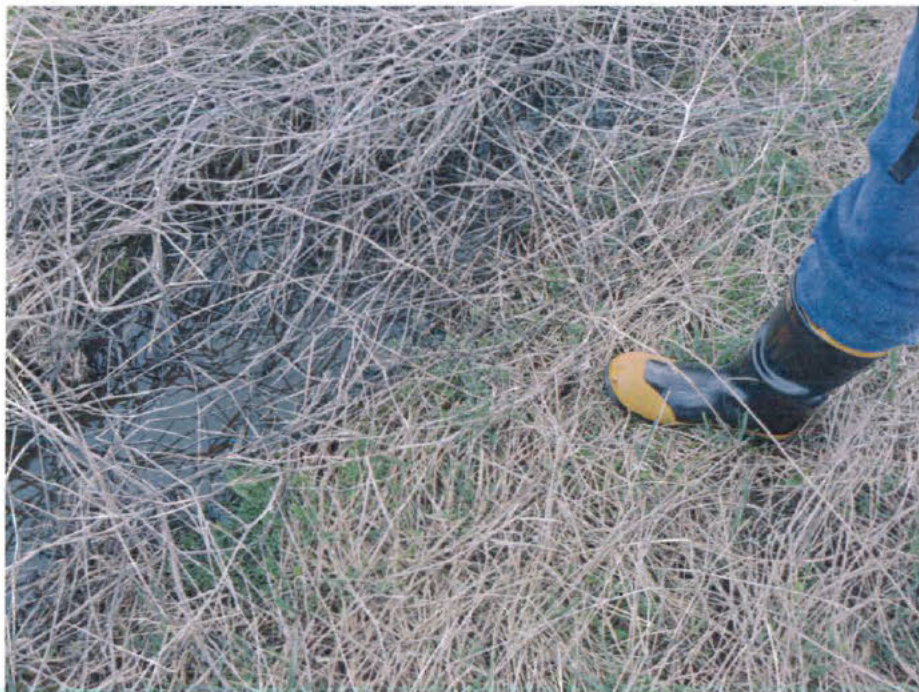
Photo #4: Close-up near the southwest corner of the (main facility) waste storage lagoon. I am standing on the lagoon wall. Note that the water level in this portion of the lagoon is near the top of the lagoon wall.

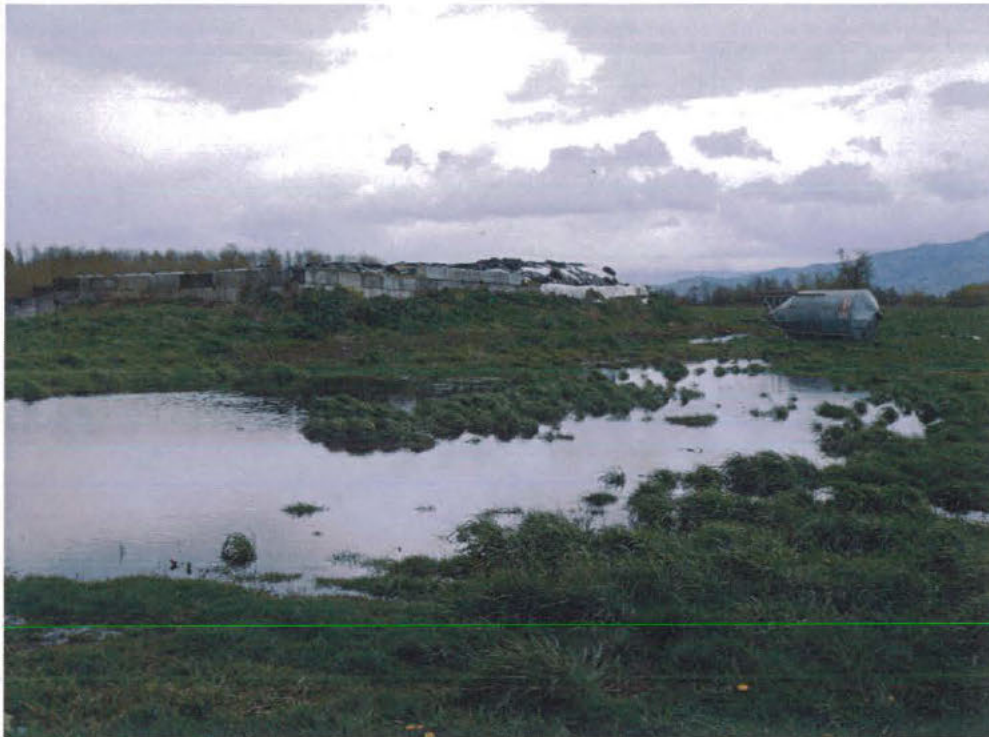
- C. Potential Silage Leachate Discharge At the time of the inspection I inspected the silage bunker at the main facility. I saw that water was accumulated just south and southwest of the silage bunker. This

accumulated water likely contained precipitation as well as silage leachate. I also saw that the water accumulated in this area was in close proximity (within a few feet) to the roadside ditch along Noon Road. See photograph #s 5 and 6 of attachment C for details.

According to Mr. Noteboom, he has installed a pump to route this accumulated water into a nearby field. However, at the time of the inspection there still appeared to be a significant amount of accumulated water in close proximity to the roadside ditch along Noon Road.

Photo #5: Easterly view showing the silage bunker in the background and ponded water in the foreground. The ponded water likely includes precipitation as well as silage leachate.

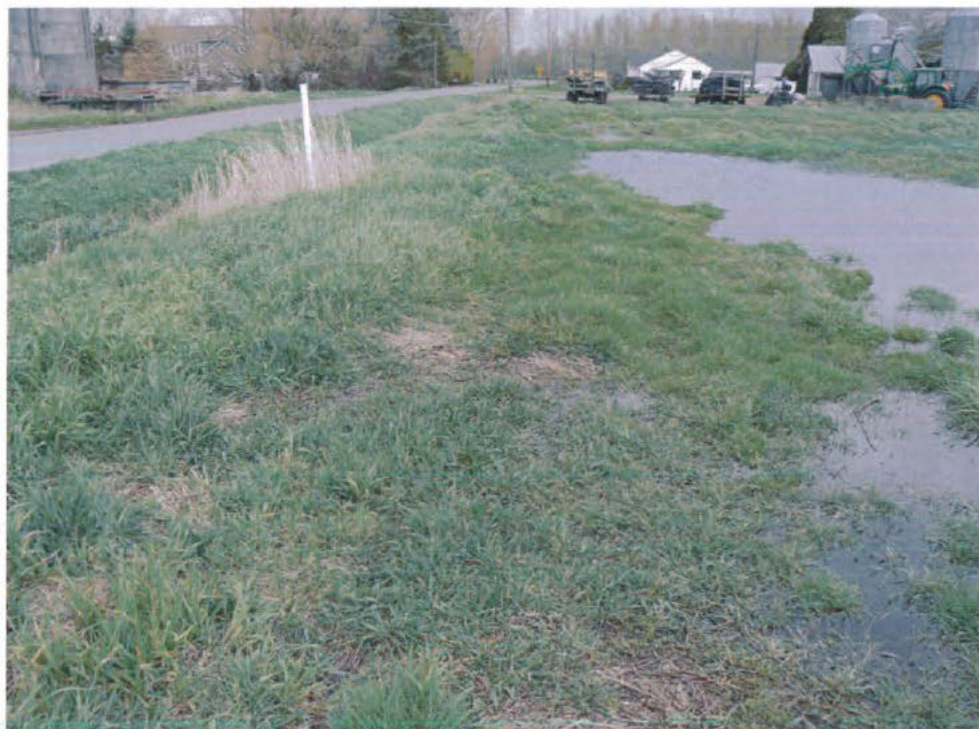
Photo #6: Northerly view showing Noon Road on the left and the ponded water near the silage bunker on the right. Note the proximity of the ponded water to the roadside ditch along Noon Road.

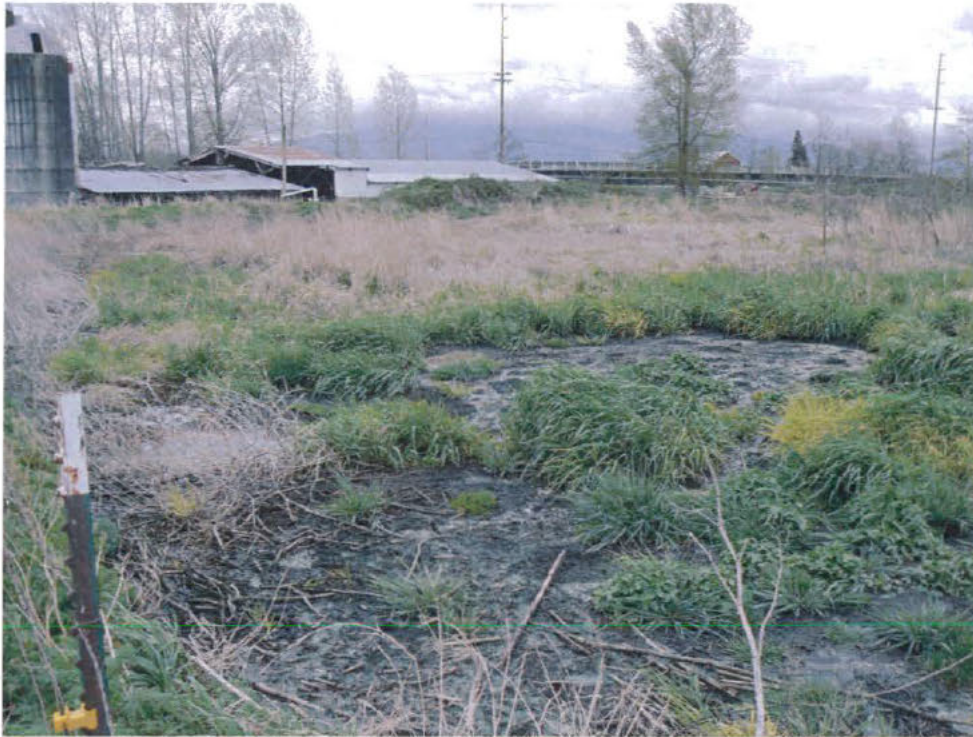
I also saw solids floating on the surface of the lagoon at the Hannegan Road location. Similar to the lagoon at the main facility, this lagoon also had vegetation growing on the floating solids mat. See photograph #s 7 to

9 of attachment C for details of the accumulated solids and vegetation in the lagoon at the Hannegan Road location.

Photo #7: Southerly view showing the waste storage lagoon at the Hannegan Road location. Note the vegetation in this lagoon.

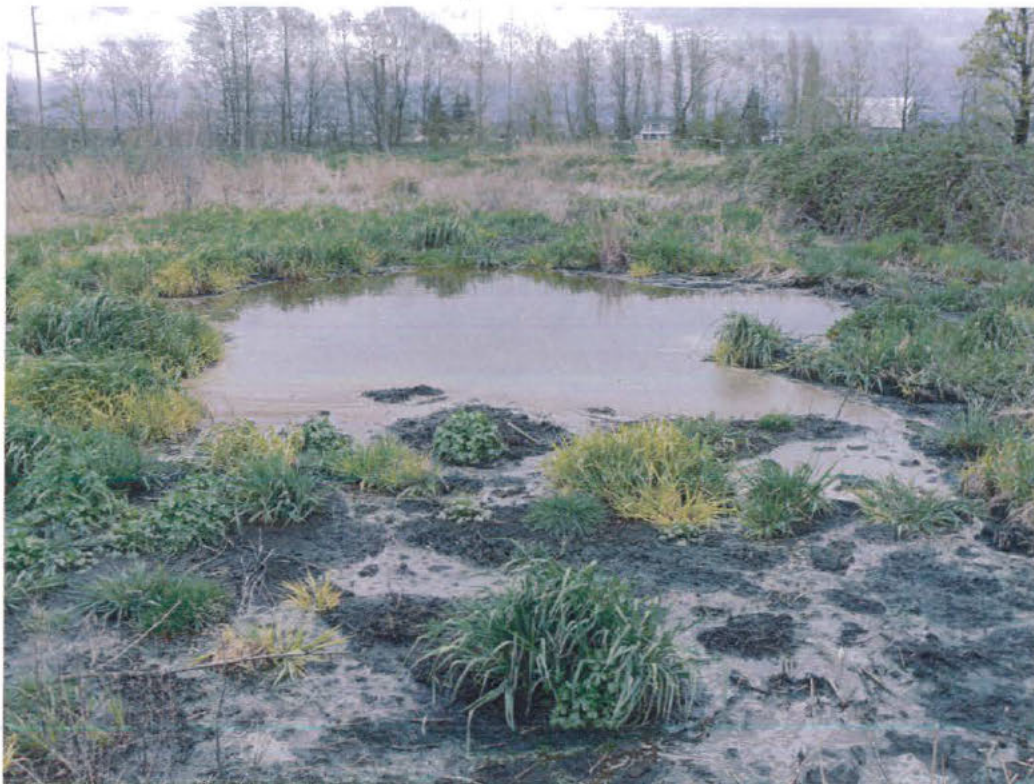
Photo #8: Another view of the waste storage lagoon at the Hannegan Road location. Note the vegetation in this lagoon.

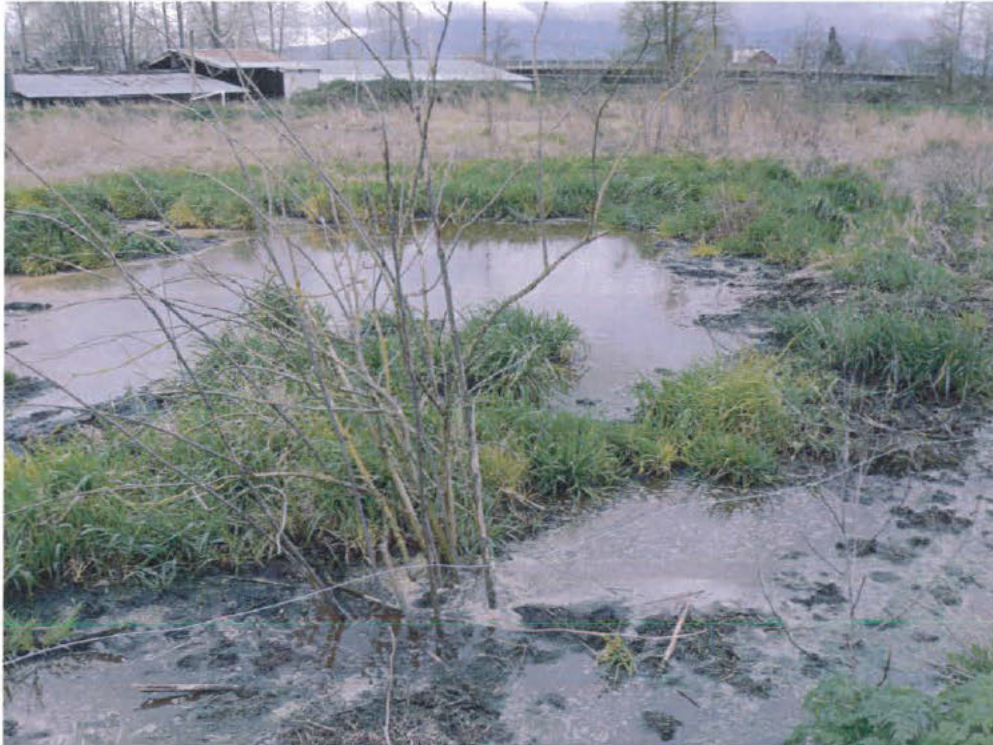
Photo #9: Close-up of some of the vegetation in the waste storage lagoon at the Hannegan Road location.
